Seismic assessment and strengthening of Dutch heritage churches with masonry vaults

Abstract

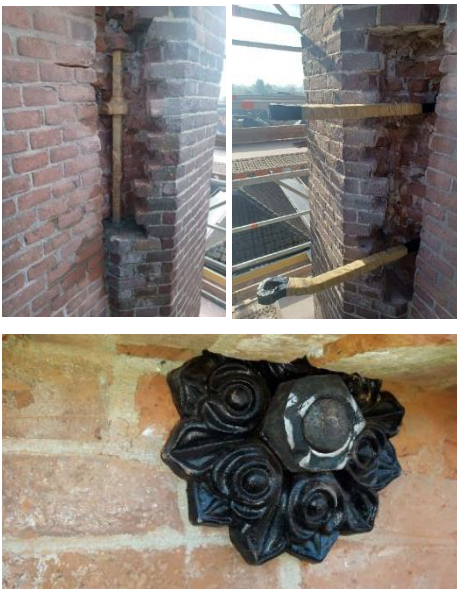
All disclaimers have been mitigated in a process with involvement of a contractor specialized in restoring of heritage buildings. Some examples of these mitigations are visualized in Figure 4.

Figure 4. concealed new anchoring and anchor plate at the extrados – all historically restored techniques

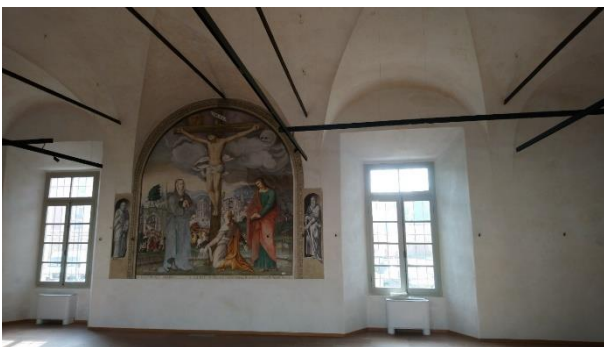
Ties at the intrados of the vaults have shown to improve the general stability and could avoid the collapse of the vaults. Ties should be anchored to the wall with external anchor plates (hidden or visible). See Figure 9.

Figure 9. Ties at intrados of the vaults, Santa Monica – Cremona (project by Studio Calvi)

Ties and rods and steel diaphragms may improve the surrounding support of the vaults but do not enhance the behaviour of the vault itself.

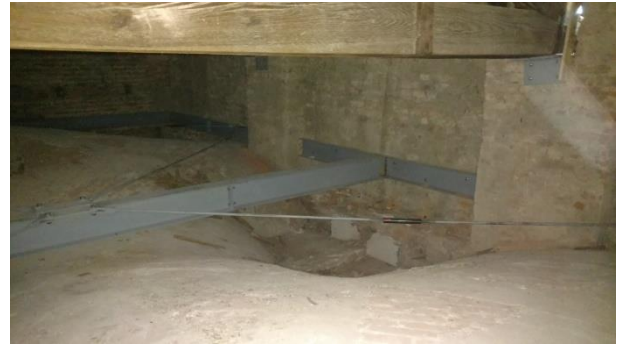
Planar deformability can be reduced creating a rigid diaphragm at the attic level. The rigid diaphragm consists of perimetral steel profile elements and bracings. See Figure 10.

Figure 10. Steel diaphragm above the vaults (Palazzo Botta Pavia – project by Studio Calvi)

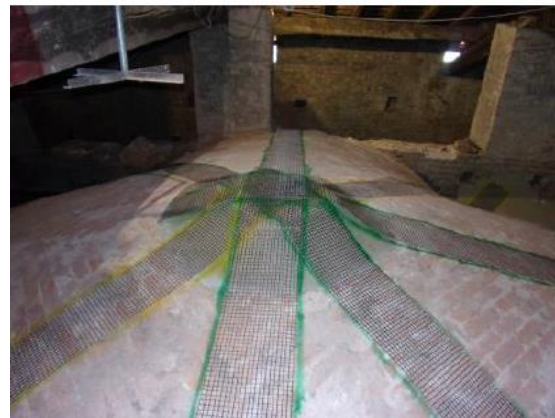
The FRCM-system represents a thin structural layer that integrates a specially formulated mortar—an inorganic matrix—with an inorganic fiber mesh reinforcement, which may include materials such as carbon, glass, basalt, aramid, or steel. See Figure 11. This approach appears to be particularly well-suited for historical masonry applications when compared to organic resins. Key advantages include superior adhesive properties in relation to rough surfaces, enhanced chemical and mechanical compatibility among materials, improved durability against environmental factors (such as fire and ultraviolet radiation), and straightforward installation processes.

Figure 11. Application of basalt fibre mesh and covering with NHL mortar, Santa Monica – Cremona (project by Studio Calvi)

Seismic strengthening in the form of reinforcement on the extrados could contribute to technical damage to both the vault and the accompanying paintings at the intrados, but is also not easily reversible. It could in addition also solve the problem of recurrent cracks in some churches, due to foundation settlements or thrust forces from the roof and the vaults. The significant visual and experiential value, available for interested public, of the upper surfaces of the vaults necessitates the maintenance of clear visibility and recognition of the underlying materials (such as tuff and brick) and the patterns of masonry bonds. Yet assessments show that this type of reinforcement is very effective, since it improves the masonry tensile strength and bonding in a very direct way. Partial cover of the vault surface by means of stripes of reinforcement could be a compromise between seismic safety and visual impact of the measure.

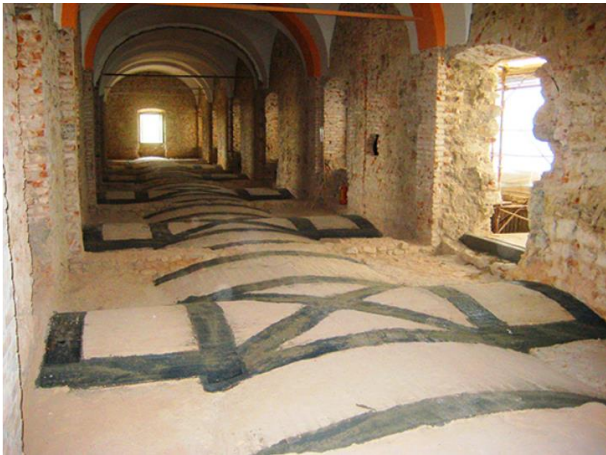
Fiber Reinforced Polymer (FRP) strengthening systems leverage the combination of high-strength, long fibers and a matrix that serves as an adhesive, facilitating the transfer of stress from the substrate to the fibers. See Figure 12. The fibers, typically made from carbon or glass, are characterized by their high Young's modulus of

elasticity and exceptional tensile strength. The matrix is predominantly composed of epoxy resins.

Figure 12. reinforcing system with FRP, ex-monastery in Bergamo (Italy), (project by Building Improving S.r.L)
